# **California Department of Forestry and Fire Protection**

**Review Report of Serious Injuries, Illnesses,  
Accidents and Near-Miss Incident**

## **Jesusita Fire Burnover**

**Firefighter Burn Injuries with Engine Burnover,  
and Additional Related Near Miss Incidents**

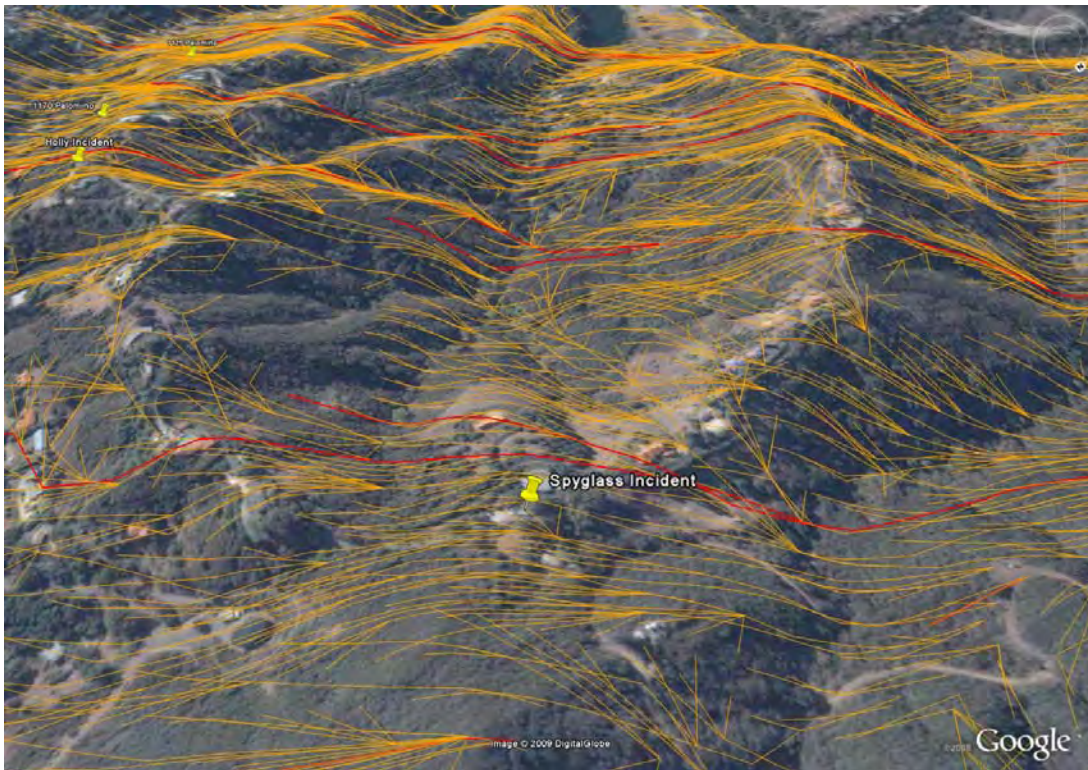
The location of the residence as it sits at the top of three drainages, with heavy fuel loading and numerous structures and out buildings caused the fire behavior to greatly increase.

The orientation of the structures and vegetation caused the fire to funnel up the driveway which was also the escape route back to VNC E-54.

Fire path at 1495 Spyglass Ridge Road

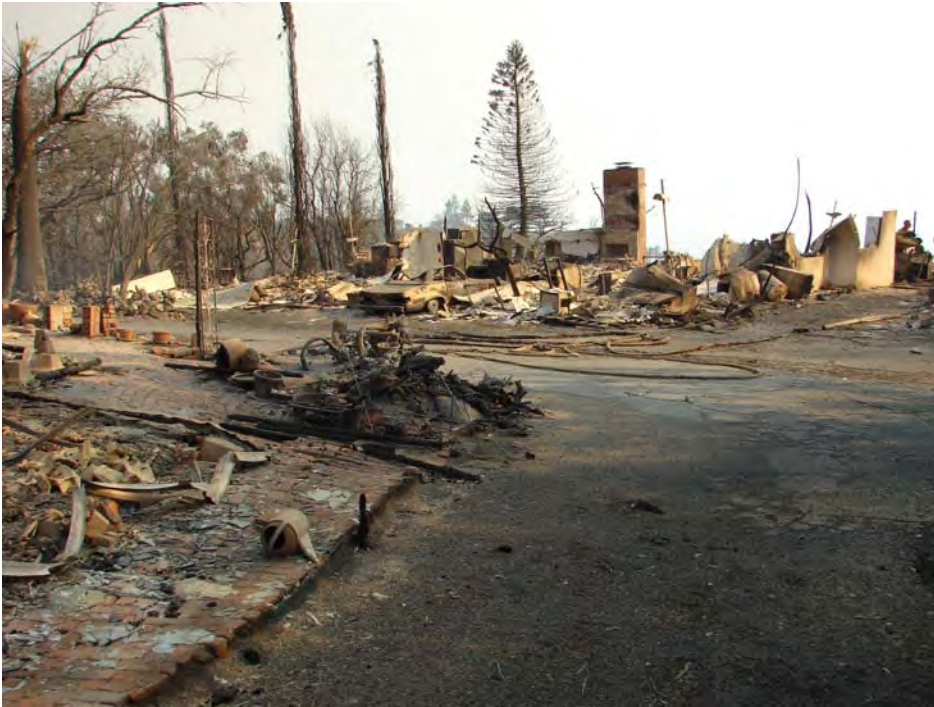
1495 Spyglass Ridge Accident site

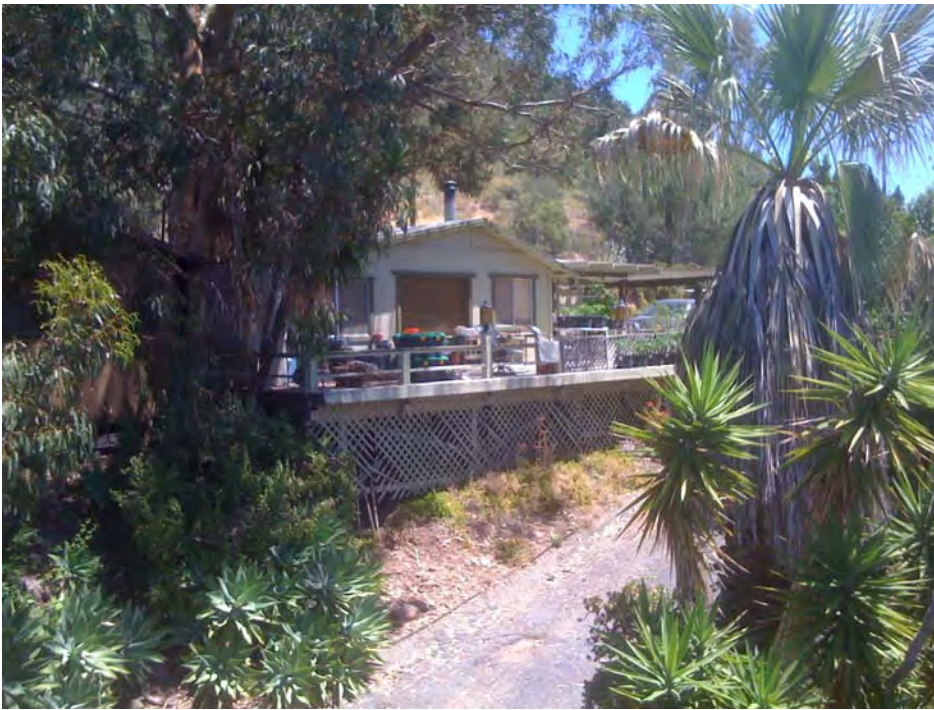
1495 Spyglass Ridge Road prior to the burn over.

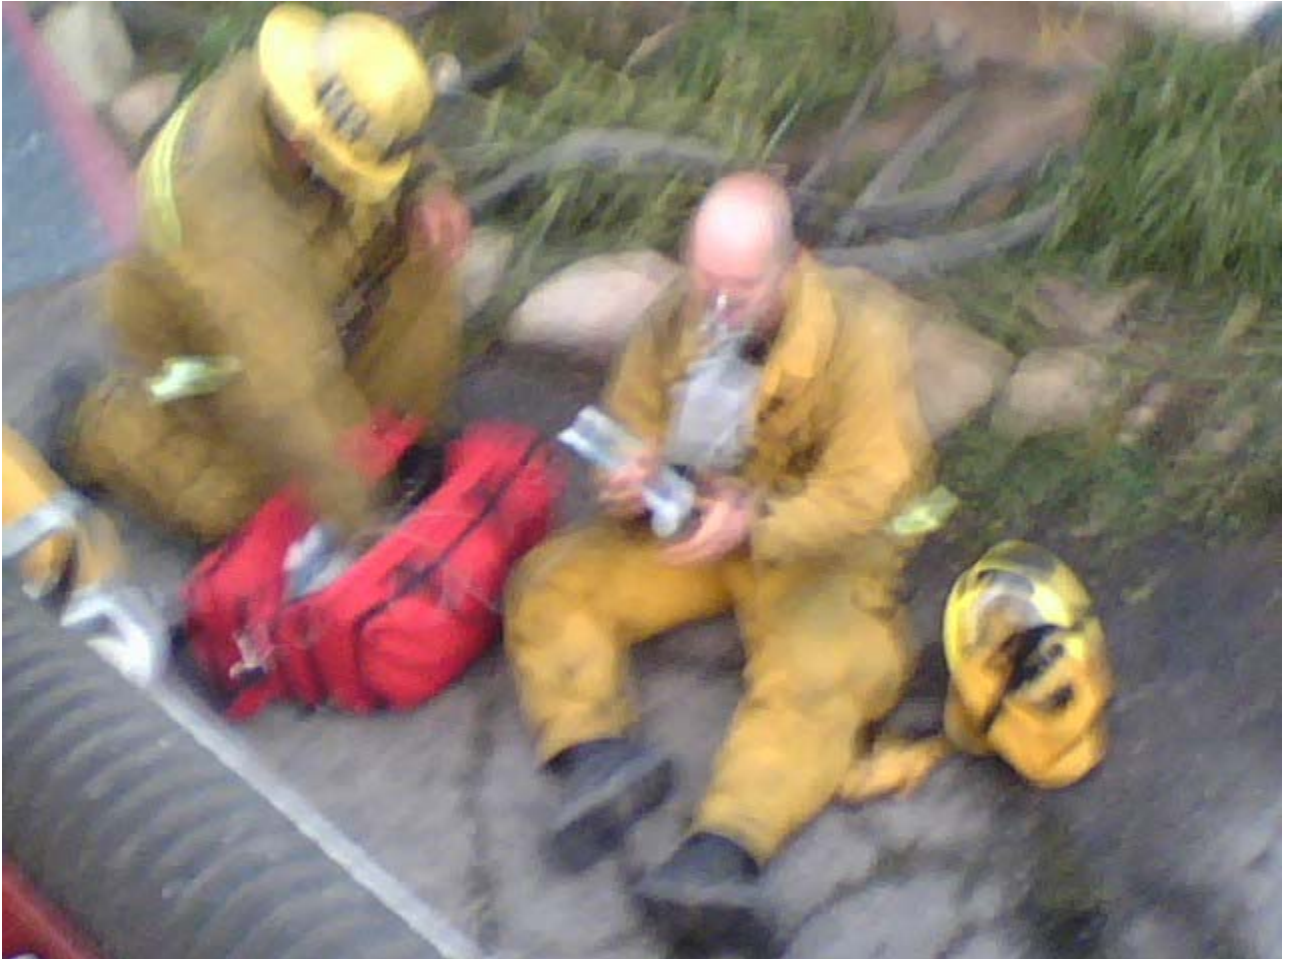
Firefighter at 1433 Mission accident site receiving breathing treatment.

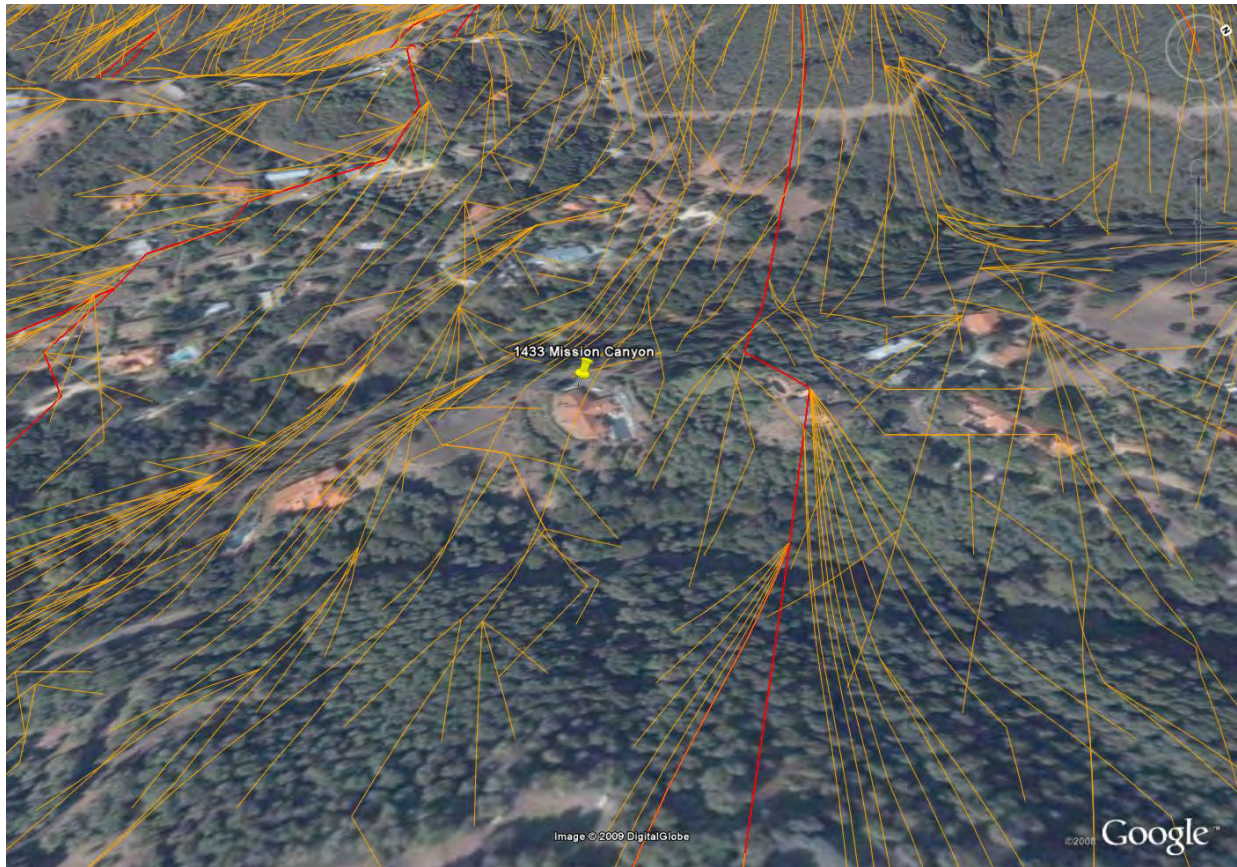
Fire path at 1433 Mission Canyon

Fire was coming from the northwest, from top to bottom in the photo

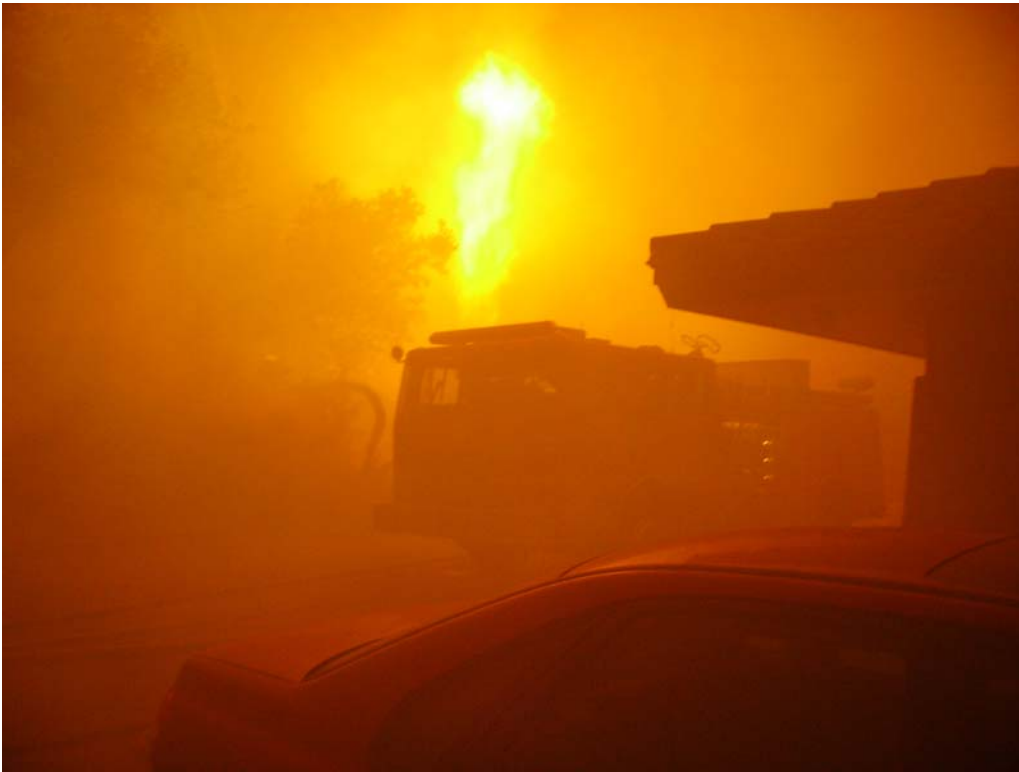
Propane tank venting at the 1433 Mission Canyon accident site

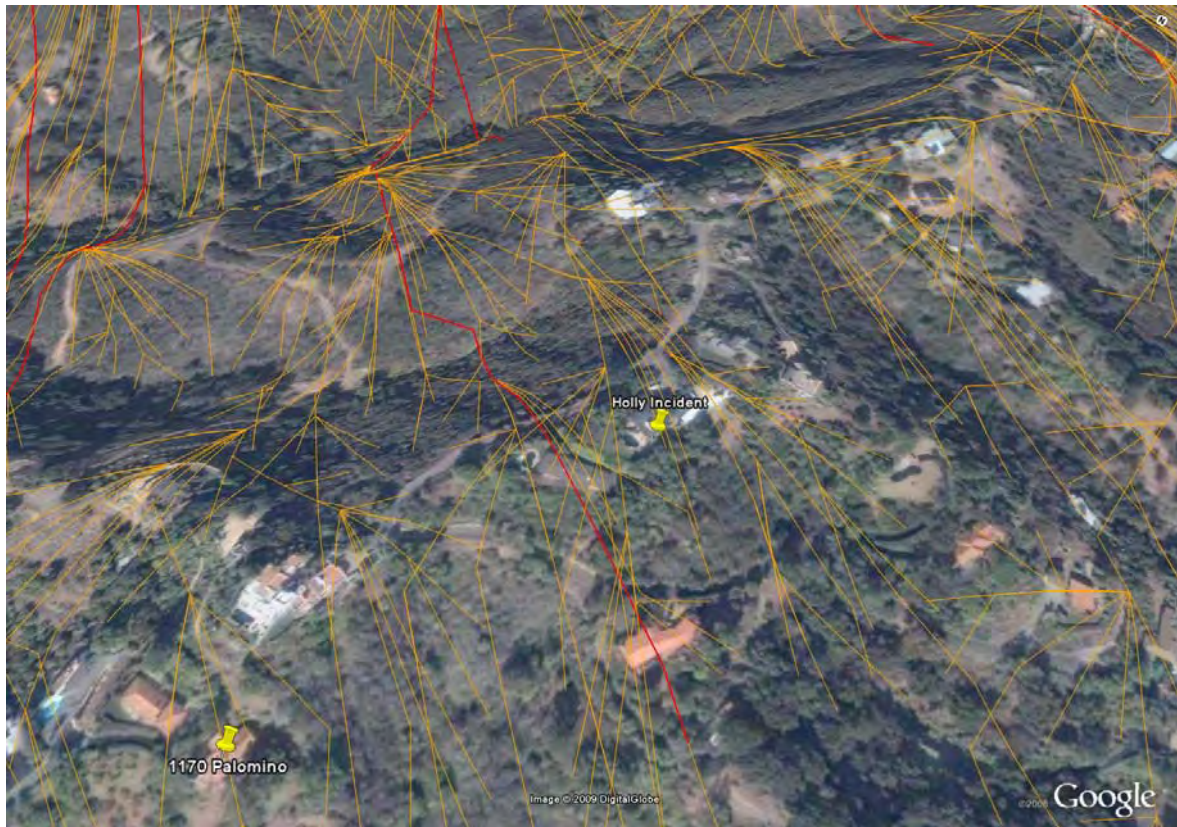
Fire path at Holly accident site.

Fire came from the northwest, from top to bottom in the photo.

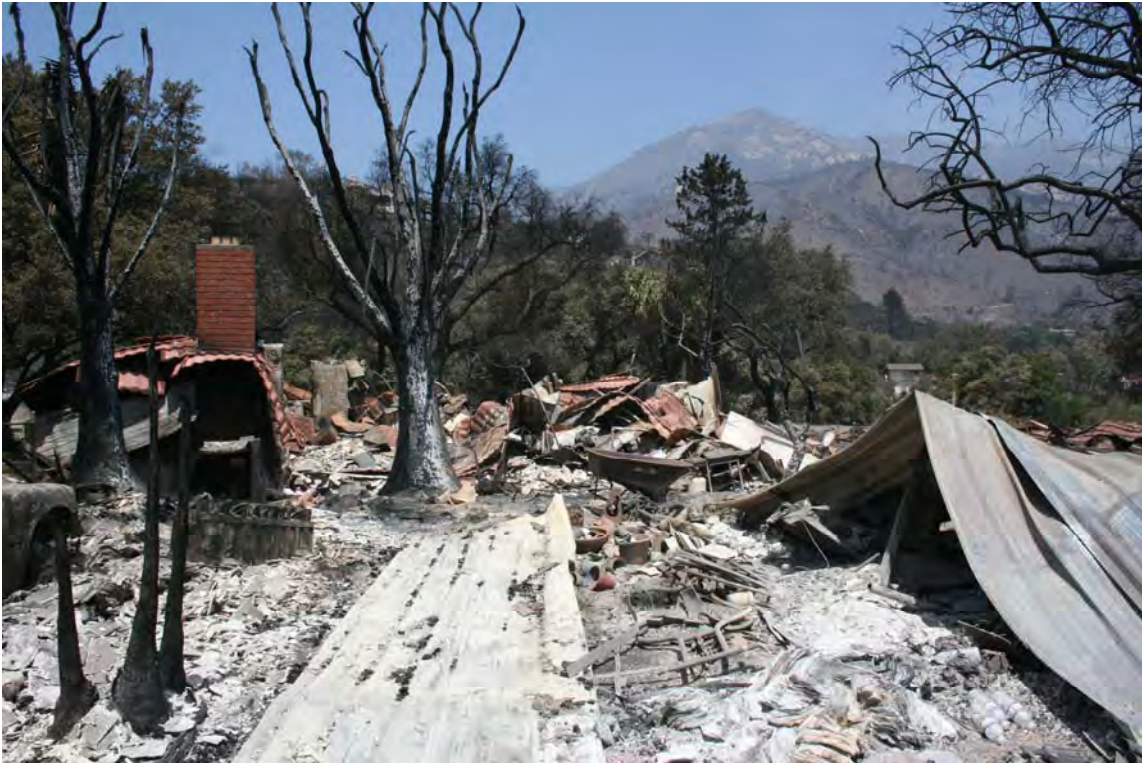
The residence at 1165 Tunnel #G failed its LE-100 inspections in 2008. The inspection program for 2009 had not started. This residence was not destroyed during the fire but the residences at 1255 and 1165 #A Tunnel were destroyed.

1165 Tunnel #G all outbuildings were destroyed.

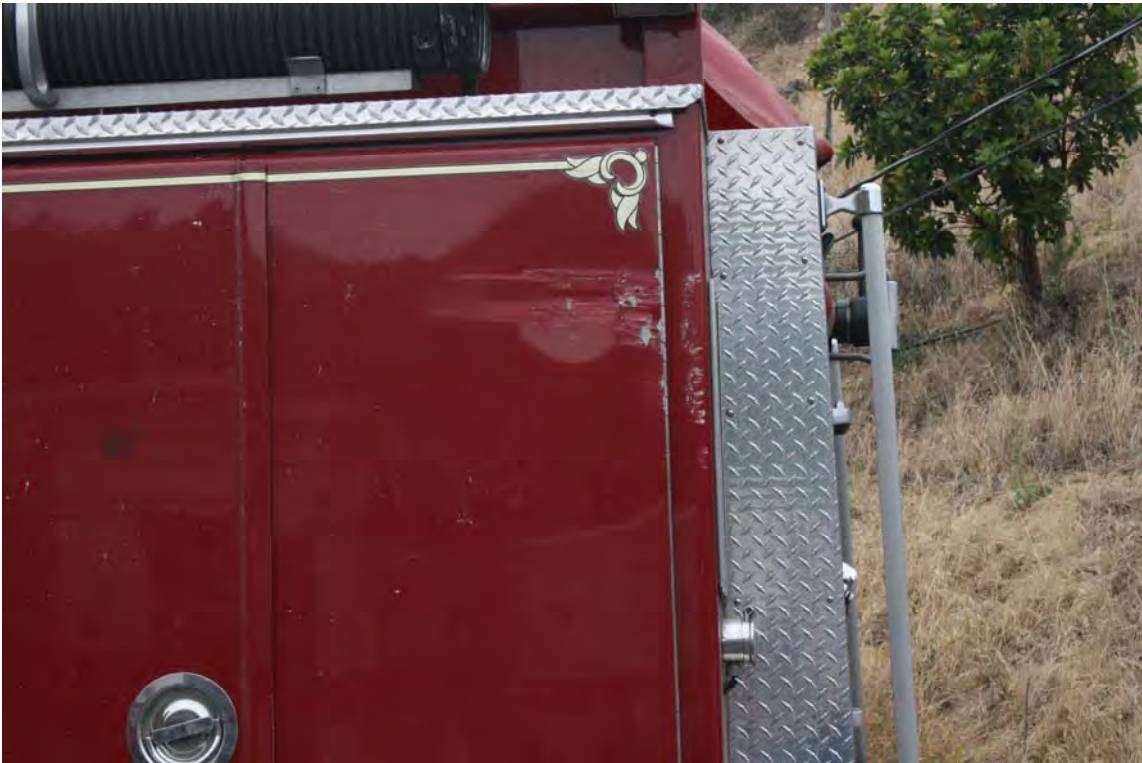
Santa Paula City E-81, damage from hitting block column.

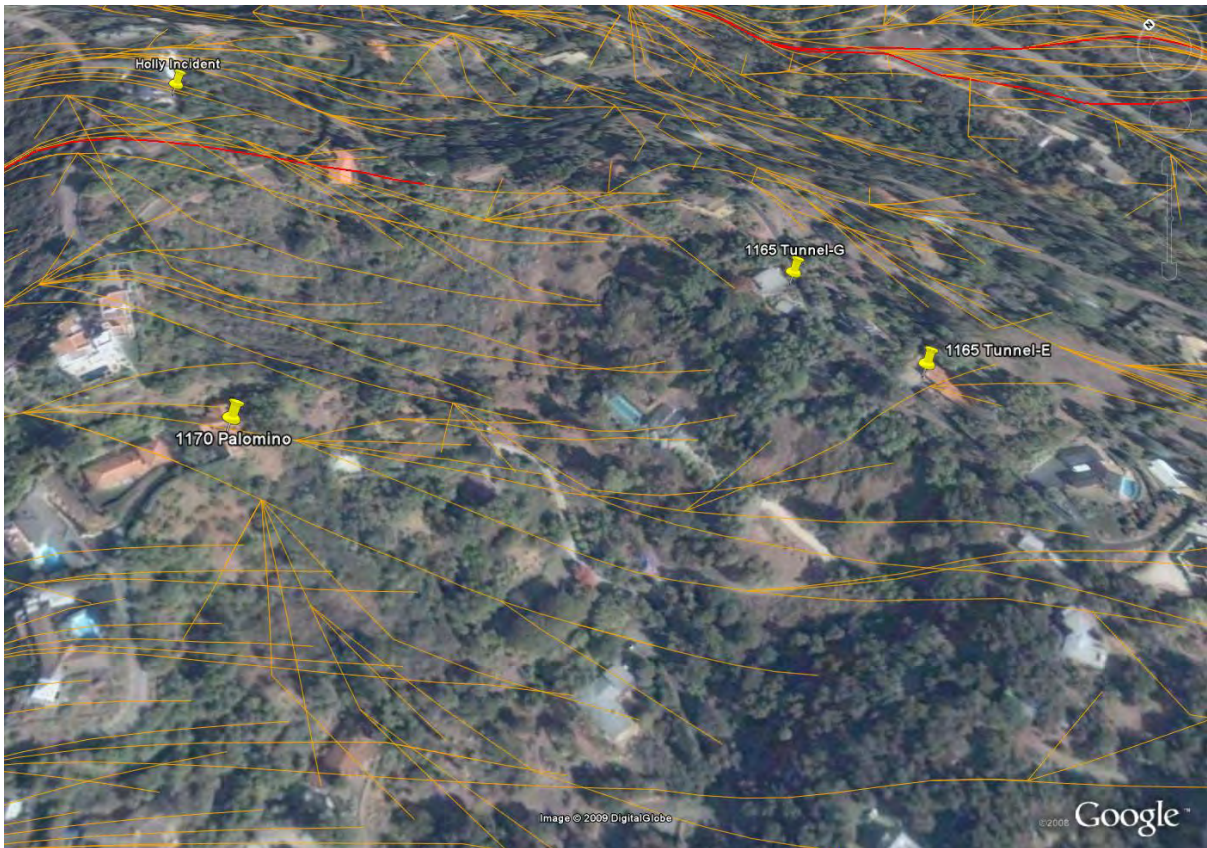
Fires path at 1165 Tunnel # E & #G

The fire came from the northwest which would be from left to right on this photo.

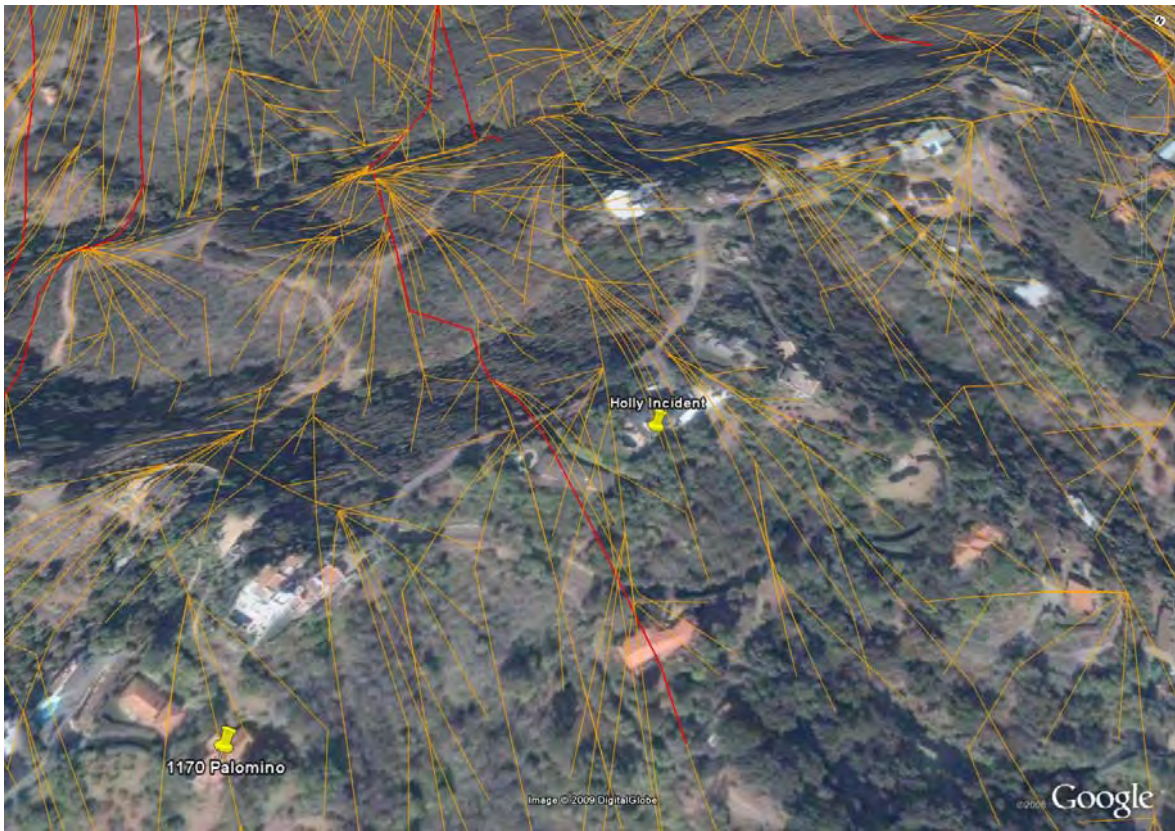
Fire path at 1125 Palomino Accident Site., From top to bottom of photo

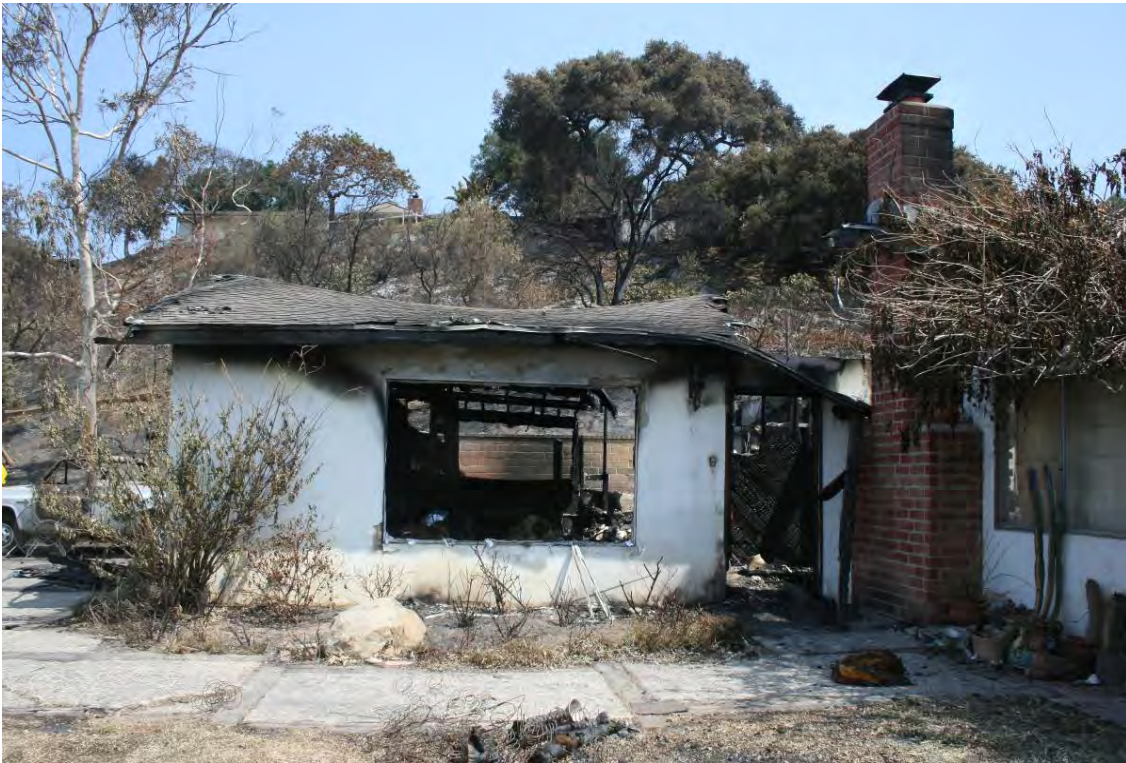
1125 Palomino Accident site where LAC-E-70 took refuge.

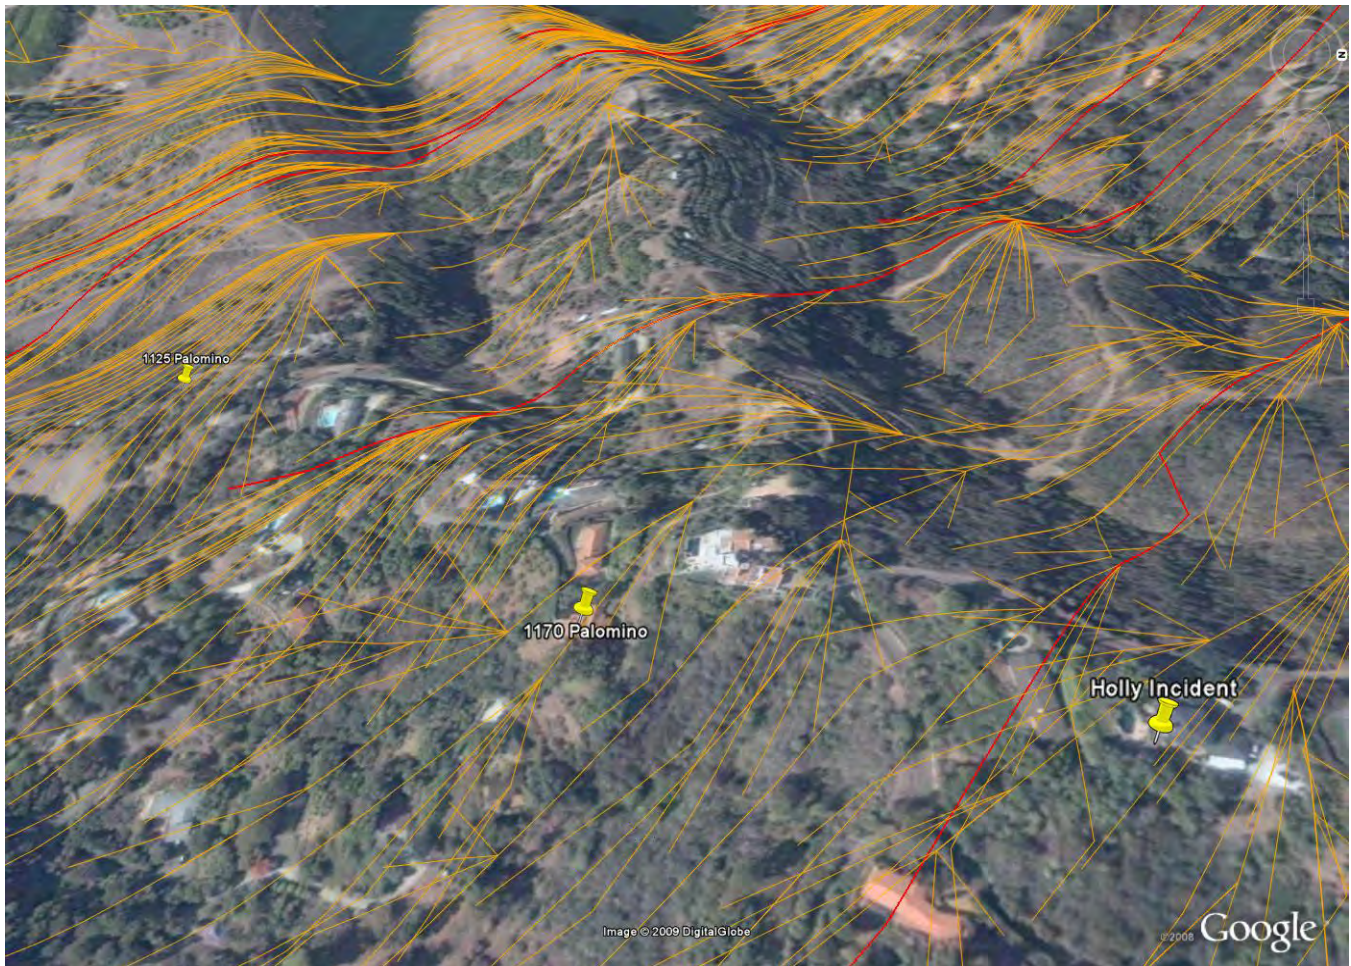
Fire path at 1125 Palomino Road

Fire came from the northwest which is the top right to bottom left in the photo.

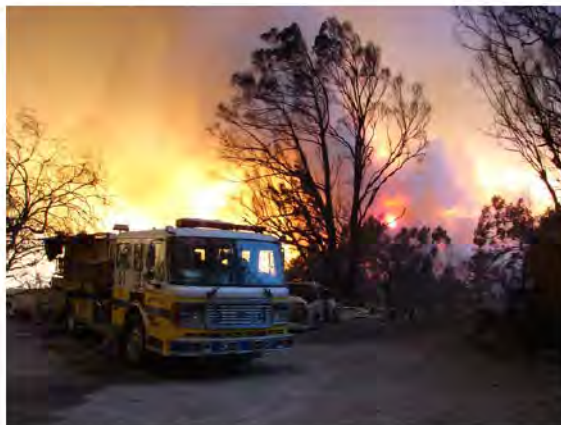
- VNC E-54 had severe fire damage to the front and left side of the apparatus. The hose bed had major damage from the cribbing and hose that caught fire. The apparatus had a transmission leak along the left frame rail, but was physically driven off the mountain.
- VNC E-30 received minor exterior heat/fire damage.

*Photo of VNC E54 taken after the burn over.*

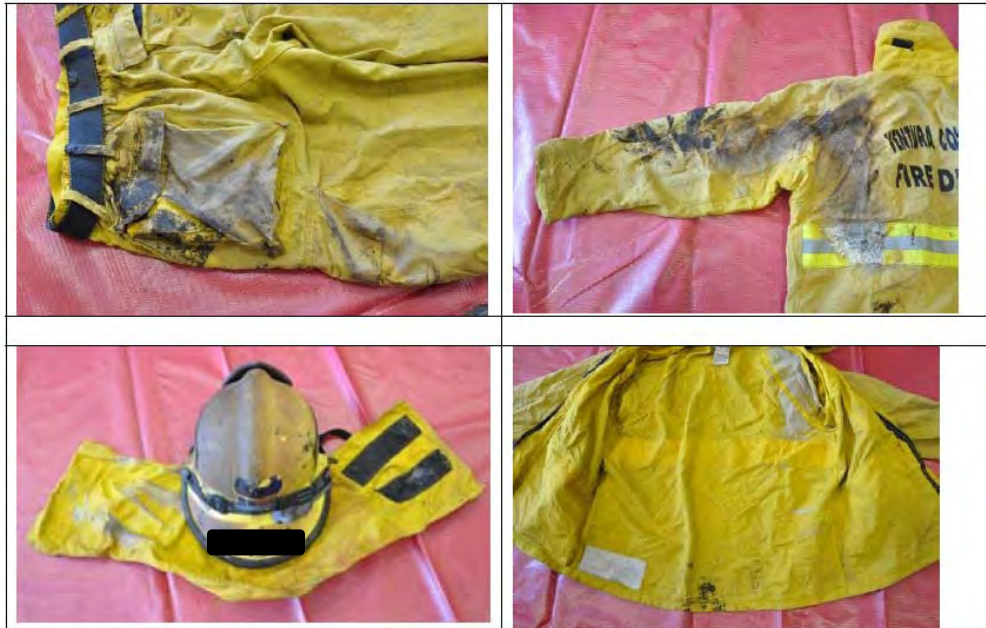
- Shroud shows dye sublimation mostly on the left side. Lines of dye sublimation shows that the shroud was crumpled during heat exposure most likely due to SCBA mask.

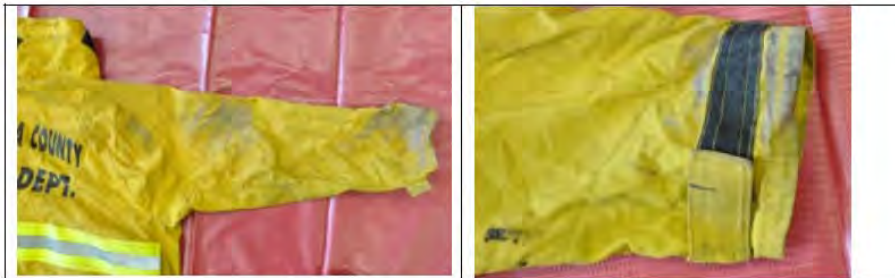
**Bin 2 – FC-54**

- Shirt:
  - Dye sublimation on both sleeve cuffs,
  - Dye sublimation on both shoulder areas
  - Dye sublimation on upper right arm and elbow area.
- Pants: No significant signs of heat.

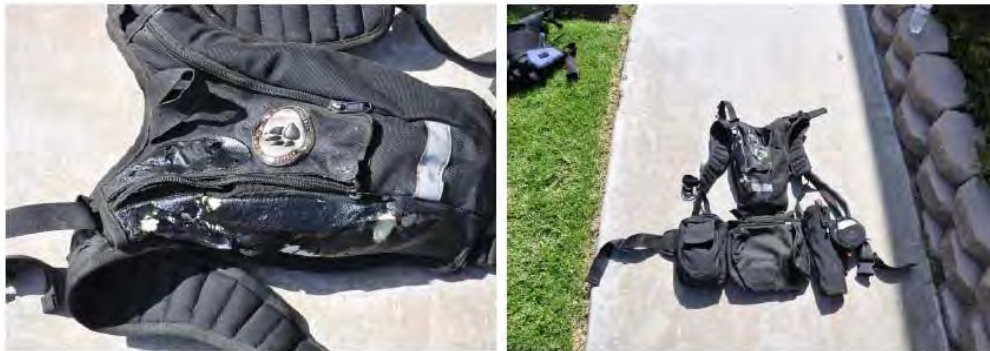
**Wolfpack Gear:**

The line gear worn by FC-54, showed areas of melted nylon cloth, buckles, webbing and hook and loop fastener. Most melting occurred on the left side of the gear. The amount of melted material shows that the high temperature and duration of the exposure was enough to raise the temperature of the nylon to over 450 degrees F. FC-54 removed his gear and SCBA when he was inside the rear seat compartment of E-54. When the gear was recovered from E-54 it was discovered that part of the melted material had adhered to a metal component of the engine cab

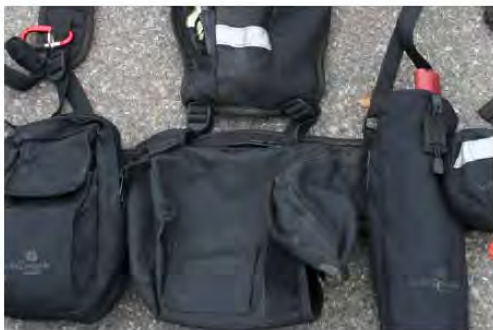
The shelter case is intact with the cover flap partially open. Minor damage is noted to the loop material at the opening.

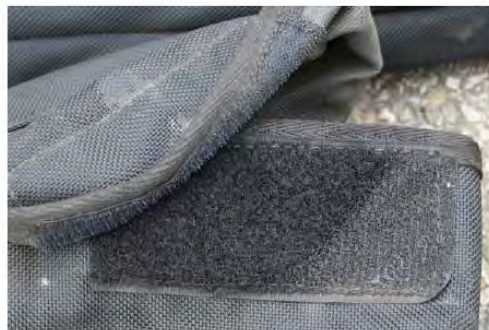
A clear line is visible indicating the position of the cover flap at the time of exposure. The damage to the loop material that was exposed is consistent with exposure to temperatures of 450 degrees and above for short periods of time. The bag did not ignite or drip.

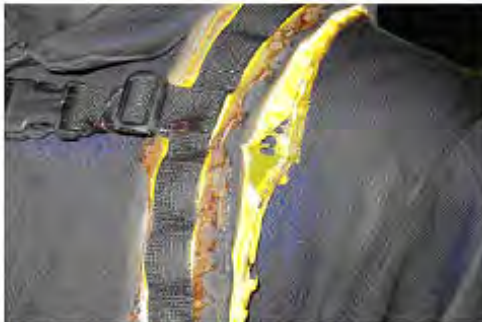
Mannequin test results at the University of Alberta.

Note that the fabric has melted onto the protective garment and the damage to the underlying foam panel.

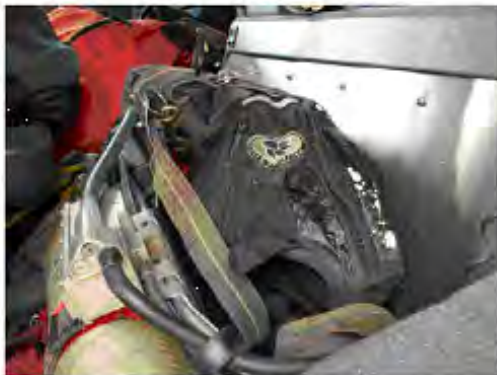
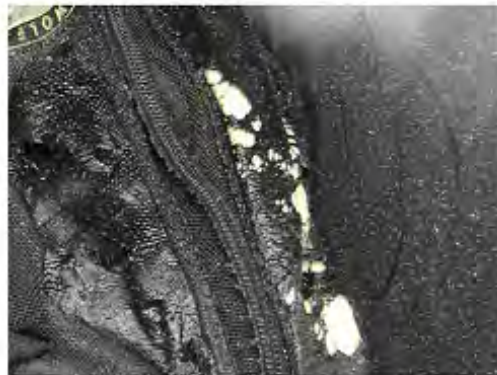
During the inspection of photographs taken at the accident site [REDACTED] pack system is seen in the right rear passenger compartment of E54 with the SCBA worn during the event. These items were discarded by [REDACTED] after seeking refuge in E54. The pack system is situated between the SCBA and the rear of the engine cover. Upon closer inspection the pack system at the point of damage to the hydration pocket is in contact with the engine cover and a melting to the cover.

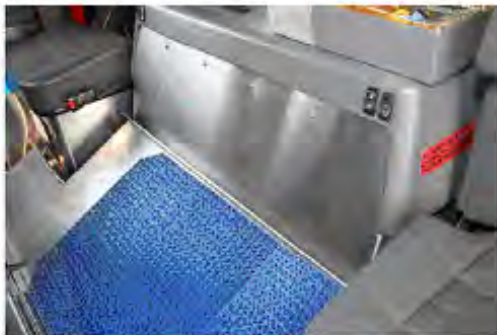
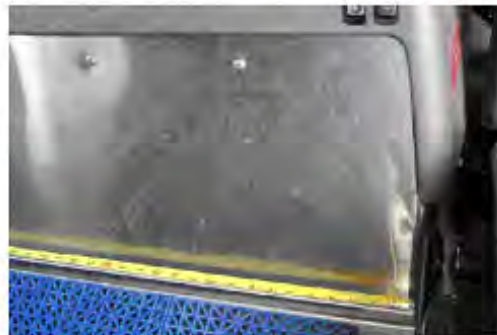
An inspection of the engine cover revealed that small pieces of the melted fabric remained on the engine cover after the removal of the pack system.

This is consistent with the earlier observation that creases, wrinkling and matting of the fabric indicate that the material was in contact with a relatively flat surface while at or very close to its melting temperature. The lack of melted material transfer to either the Nomex jacket or SCBA indicates that the melting most likely did not occur until the pack was removed and discarded in E54.
